Evaluation of Laminar Flow Aeration, Bioaugmentation, and Biological Control for Improvements to Paradise Lake, Emmet and Cheboygan Counties, Michigan

**Jennifer L. Jermalowicz-Jones, PhD Candidate
Water Resources Director
Restorative Lake Sciences
18406 West Spring Lake Road
Spring Lake, MI 49456**

November, 2013

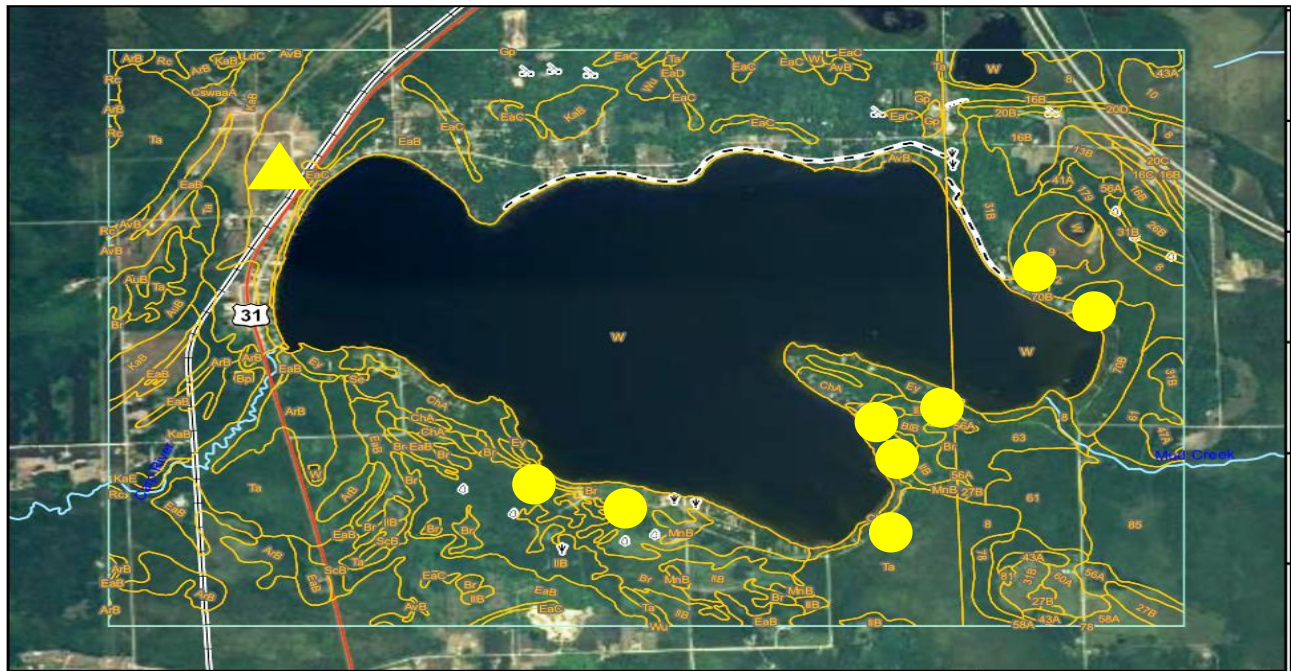
Figure 21. Map showing the mucky soils (denoted by yellow circles) and high erosion sands (denoted by a yellow triangle) around the shoreline of Paradise Lake. (Data and map collected by the USDA-NRCS).

The areas denoted with yellow circles contain mucky soils that are prone to saturation and ponding and thus are associated with increased runoff during heavy rains. These areas are also the most susceptible for contributing septage that may be backing up onto lawns from full septic systems. The area denoted by a yellow triangle at the west end of the lake indicates an area of high slope where erosion of loamy sand may contribute to sediment loading to the lake.

Although the majority of the lake is surrounded by loamy sands, the areas above denoted by yellow circles are mucky soils that are prone to ponding. It is critical that the drain fields in these areas be maintained with low soil compaction to avoid the probability of septage running off from the land during a heavy rainfall event. In addition, the areas around the remainder of the lake that contain loamy sands are susceptible to rapid permeability of septage through sands and eventually to the water table. It is a challenge to determine if septic systems are failing from a shoreline survey. Inspections of each drain field system must be conducted to determine the operational efficiency of the septic system and to determine if leaching of septage has occurred. In addition, placement of seepage meters underwater near shoreline areas would be needed to determine if septage is entering lake water via the water table and contributing to water quality degradation (such as increased bacteria levels or submersed aquatic plant growth).
