**Paradise Lake “State of the Lake” (2017)
Report: Evaluation of Laminar Flow Aeration,
Bioaugmentation, and Biological Control for
Improvements to Paradise Lake, Emmet and
Cheboygan Counties, Michigan**

Paradise Lake “State of the Lake” (2017) Report: Evaluation of Laminar Flow Aeration, Bioaugmentation, and Biological Control for Improvements to Paradise Lake, Emmet and Cheboygan Counties, Michigan

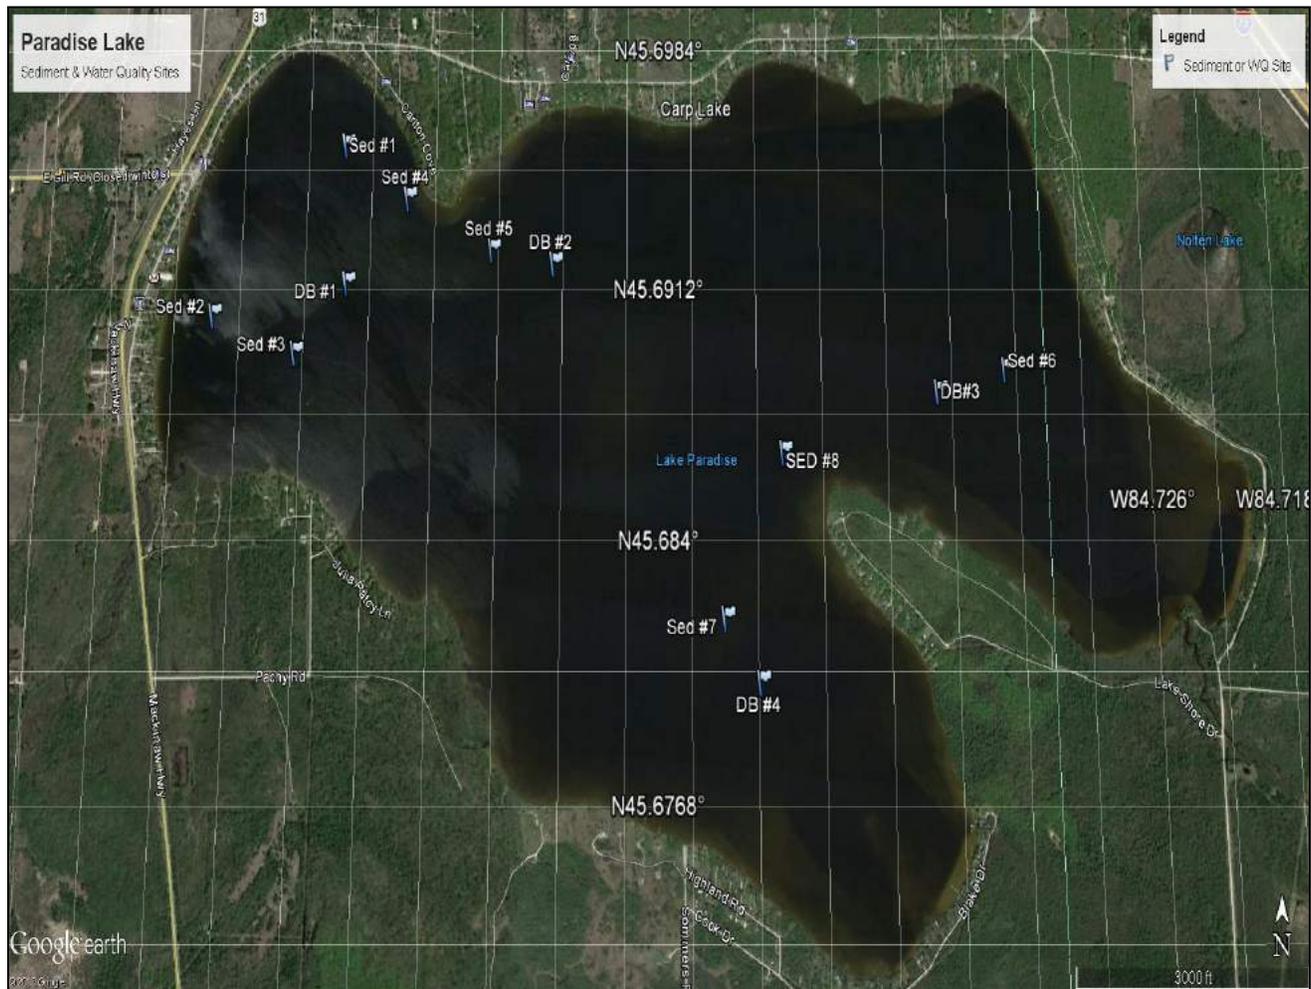
Figure 1. Water quality and sediment sampling locations in Paradise Lake, Emmet and Cheboygan Counties, Michigan (August 21, 2017).

2017 water quality data for Paradise Lake are shown below in Tables 2-6. Table 7 shows the relative algal community composition. Sampling sites are shown in Figure 1 below.

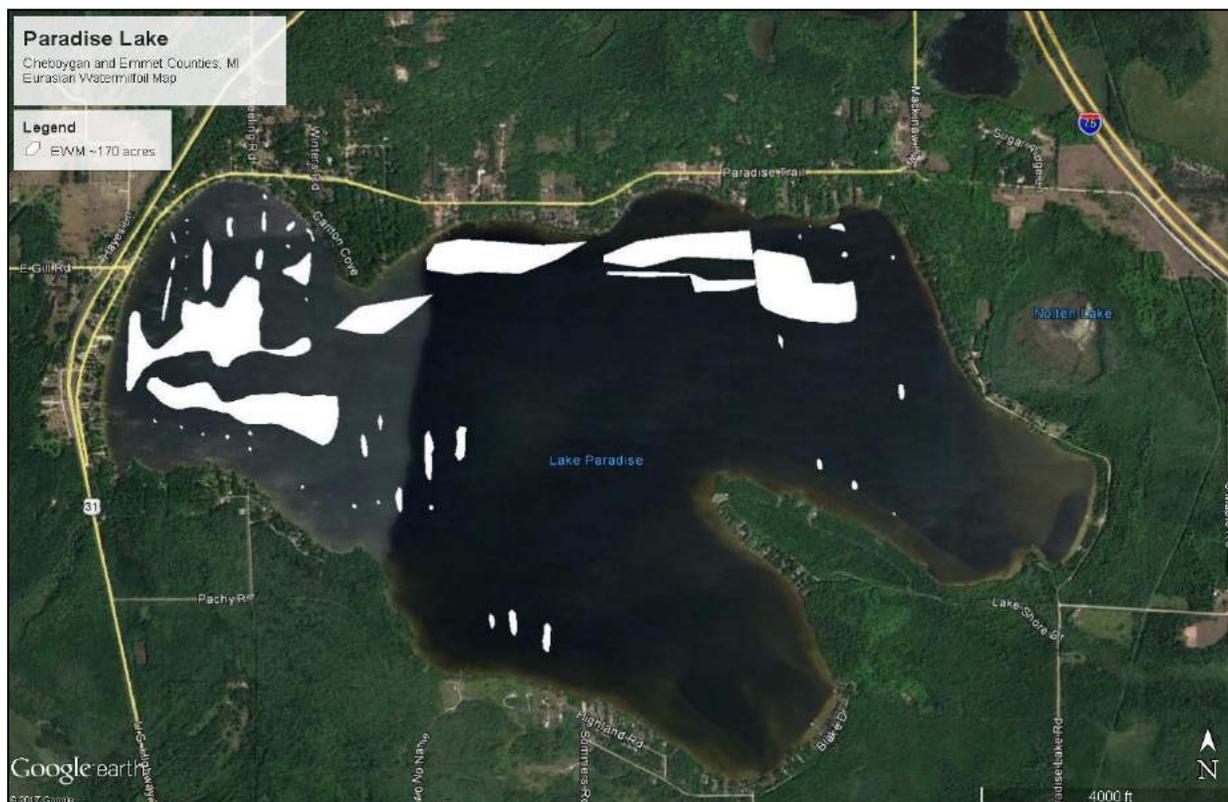
The amount of Eurasian Watermilfoil (EWM; Figure 2) present in Paradise Lake varies each year and is dependent upon climatic conditions, especially runoff-associated nutrients. The August 21, 2017 survey revealed that approximately 170 acres of the lake was covered with milfoil. Approximately 70 acres of this is currently present in the West Basin of the lake. Paradise Lake did not contain any other invasive aquatic plant species in 2017. Figure 3 below shows the aquatic vegetation biovolume map which also shows the milfoil locations in red since they correspond with milfoil growth areas.

Figure 2. EWM bed locations in Paradise Lake (August 21, 2017).

Continuous aquatic vegetation surveys are needed to determine the precise locations of EWM or other problematic invasives in Paradise Lake as well as monitor the abundance and distribution of native aquatic plants throughout the lake. These surveys should occur in late-June to early-October of year for the best results.

The aeration system has reduced the overall growth and distribution of EWM present in the West Basin and the weevil activity is still apparent on EWM stems throughout the lake. RLS recommended an additional aeration system at the northeast region of the lake to reduce nuisance aquatic vegetation growth in that area. If that system is installed in 2018, RLS will be carefully monitoring the efficacy of that system by collecting many additional sampling point data sets in that region.

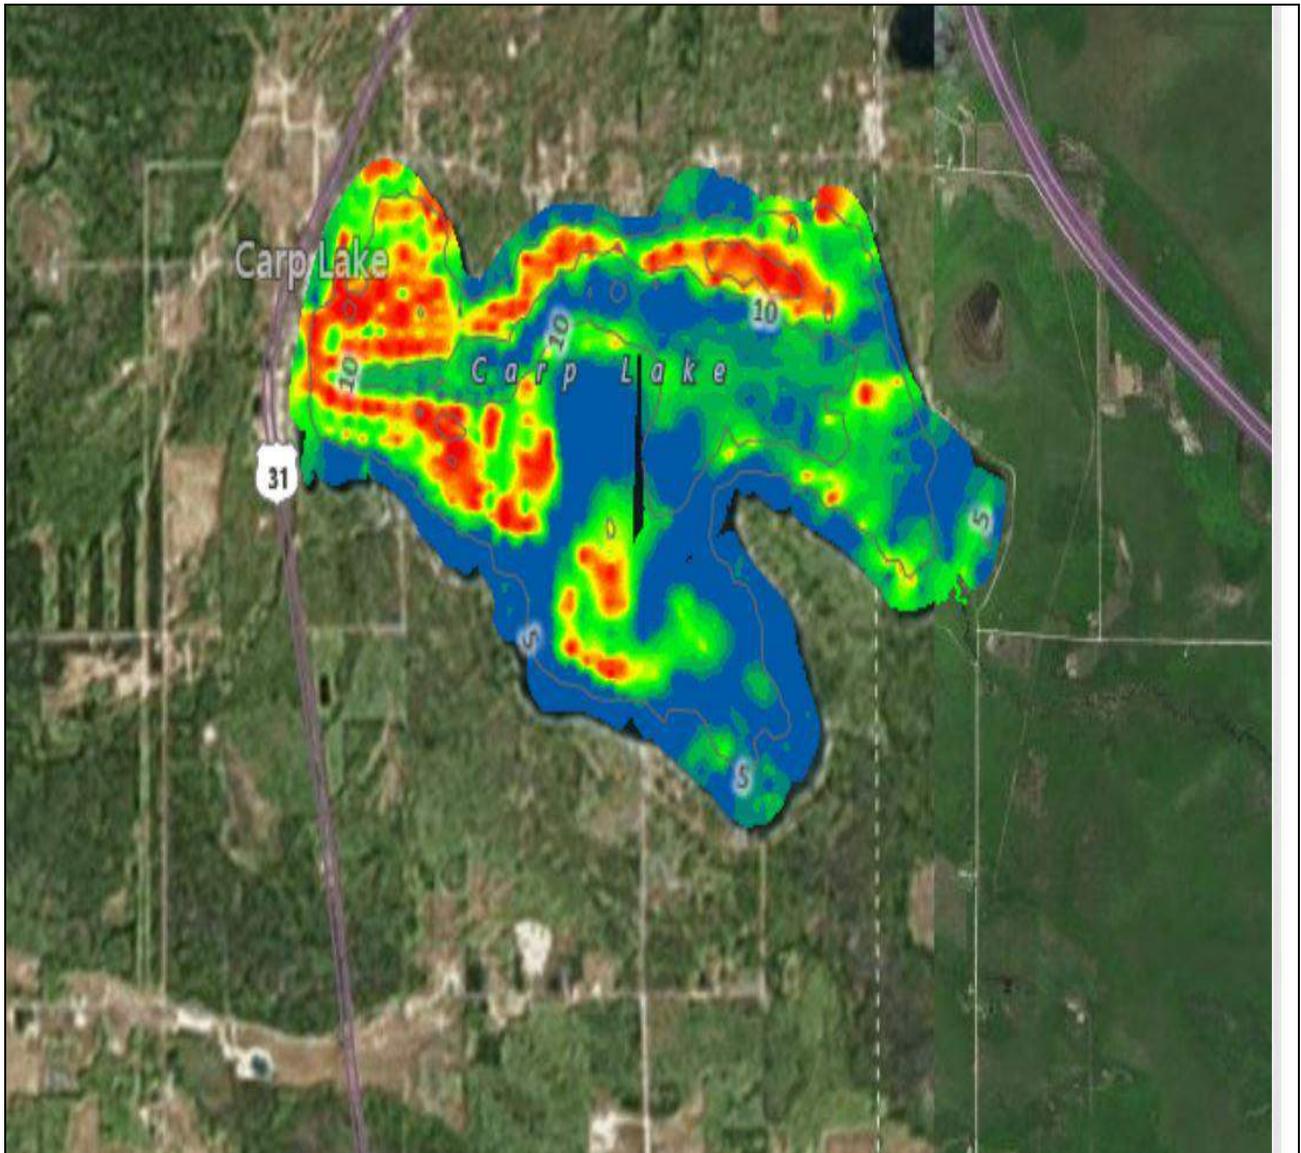
Figure 6 below shows the aquatic vegetation biovolume which corresponds to milfoil in all of the basins. Table 11 below demonstrates the changes in aquatic vegetation biovolume since 2014. As is evident, there has been an increase in low-growing favorable aquatic plants and a decline in the dense vegetation over time.

Figure 3. Paradise Lake 2017 aquatic vegetation biovolume map. Note: Red denotes high-growing aquatic vegetation and/or lily pads. Green denotes low-growing aquatic vegetation. Blue denotes a lack of aquatic vegetation.

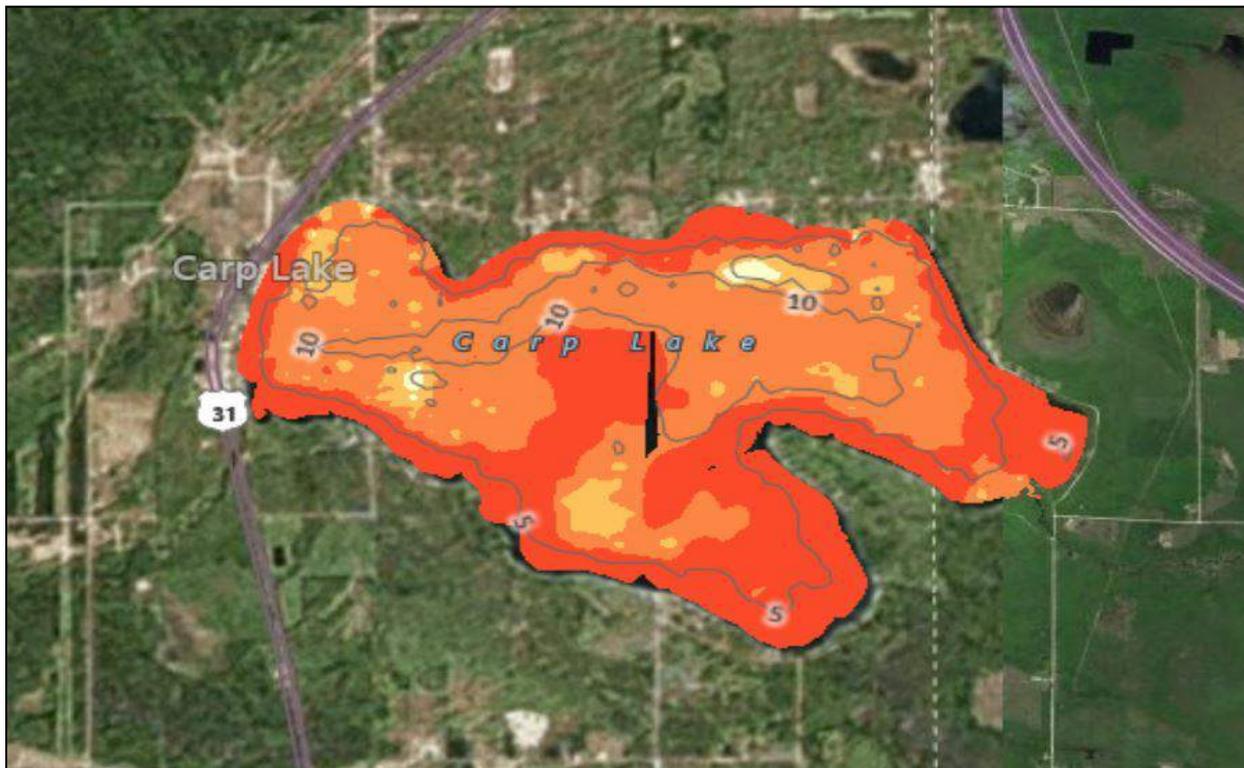
Restorative Lake Sciences conducted another whole-lake scan of the sediments in Paradise Lake. Figure 3 below shows the overall sediment bottom hardness categories and Table 12 shows the changes in sediment bottom hardness over the past few years. There has been a significant reduction in soft organic bottom and an increase in firm bottom substrate.

Figure 4. Sediment bottom hardness map of Paradise Lake (2017).

The nutrient concentrations in the lake are moderate and the majority of the aquatic plants obtain nutrition from the lake sediments. Fortunately, the soft bottom muck is declining and thus the sediments will not supply as much nutrient to vegetation in future years which should further reduce EWM and other nuisance growth. This loss of soft bottom is evidenced not only by declines in overalls ample organic matter content but also by the loss in soft bottom as evidenced by the bottom hardness maps with time
