Paradise Lake 2023 Annual Progress Report

November, 2023

Prepared for: Paradise Lake Improvement Board
C/o Mr. Paul Teike, Chair
P.O. Box 52
Carp Lake, MI 49718

Prepared by: Dr. Jennifer L. Jermalowicz-Jones, CLP
Restorative Lake Sciences
18406 West Spring Lake Road
Spring Lake, Michigan 49456
616.843.5636

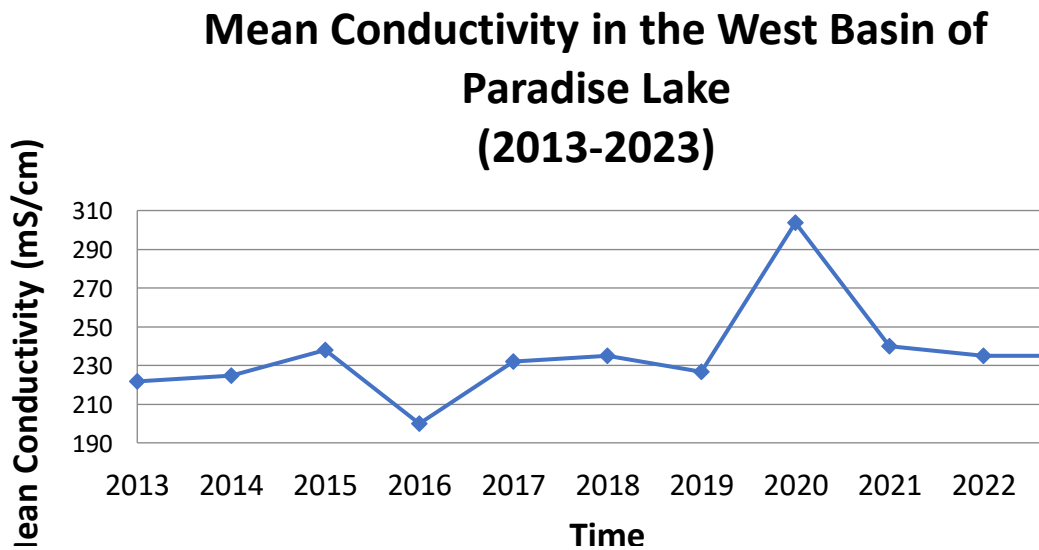
Figure 4: Average conductivity within Paradise Lake’s west basin since 2013.

Specific conductivity is a measure of the number of mineral ions present in the water, especially those of salts and other dissolved inorganic substances that can conduct an electrical current. Specific conductivity generally increases with water temperature and the amount of dissolved minerals and salts in a lake. Specific conductivity was measured in micro Siemens per centimeter ($\mu\text{S}/\text{cm}$) with the use of a calibrated Eureka Manta II® specific conductivity probe and meter. Specific conductivity values for Paradise Lake were identical among depths at the deep basin and were recorded at 235.84 mS/cm which are moderate and favorable values.

Baseline parameter data such as specific conductivity are important to measure the possible influences of land use activities (i.e., road salt influences) on Paradise Lake over a long period of time, or to trace the origin of a substance to the lake in an effort to reduce pollutant loading. Elevated conductivity values over 800 mS/cm can negatively impact aquatic life.

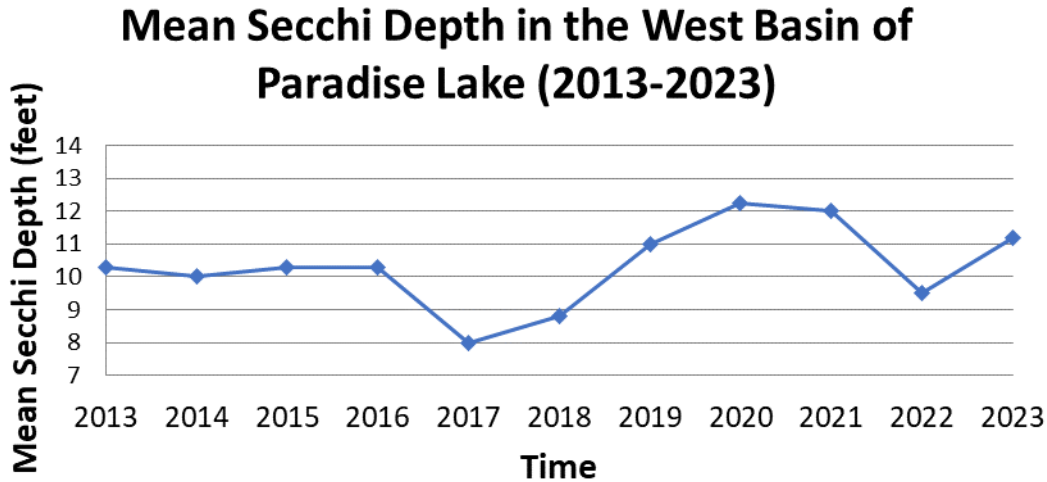
Figure 10: Average Secchi depth readings on Paradise Lake since 2013.

Secchi transparency is a measure of the clarity or transparency of lake water and is measured with the use of an 8-inch diameter standardized Secchi disk. Secchi disk transparency is measured in feet (ft.) or meters (m) by lowering the disk over the shaded side of a boat around noon and taking the mean of the measurements of disappearance and reappearance of the disk. Elevated Secchi transparency readings allow for more aquatic plant and algae growth. Eutrophic systems generally have Secchi disk transparency measurements less than 7.5 feet due to turbidity caused by excessive planktonic algae growth. The Secchi transparency of Paradise Lake was measured on September 28, 2023 and averaged around 11 feet over the West Basin which is very favorable. Measurements were collected during calm conditions (winds out of the northwest at 5-10 mph in the early morning). This transparency indicates a low quantity of suspended particles and algae throughout the water column which would result in better water clarity.

Secchi transparency is variable and depends on the amount of suspended particles in the water (often due to windy conditions of lake water mixing) and the amount of sunlight present at the time of measurement. Secchi transparency has increased throughout time due to the presence and abundance of Zebra Mussels which filter the algae out of the water for food.

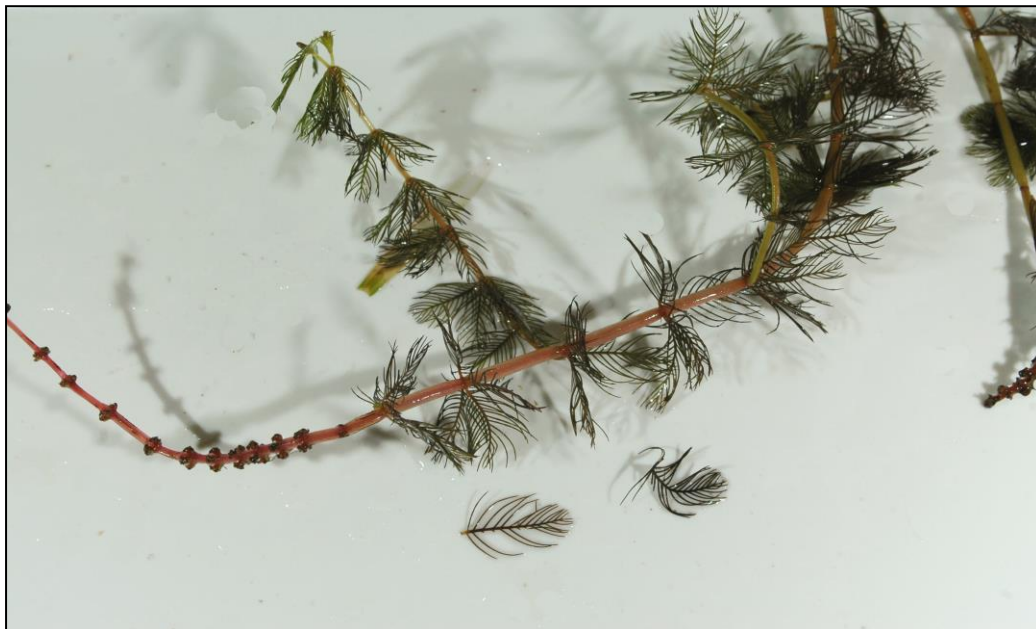
Figure 12. Eurasian Watermilfoil with seed head and lateral branches.
© RLS

Eurasian Watermilfoil (*M. spicatum* or EWM; Figure 12) is an exotic, invasive, submersed, perennial aquatic plant which was introduced into the United States in the 1880's (Reed 1997), although other reports (Couch and Nelson 1985) suggest it was discovered in the 1940's. Exotic aquatic plants are not native to a particular site but are introduced by some biotic (living) or abiotic (non-living) vector. Such vectors include the transfer of aquatic plant seeds and fragments by boats and trailers (especially in lakes with a public access site), waterfowl, or by wind dispersal. In addition, exotic species may be introduced into aquatic systems through the release of aquarium or water garden plants into a water body. An aquatic exotic species may have profound impacts on the aquatic ecosystem. EWM is a major threat to the ecological balance of an aquatic ecosystem through causation of significant declines in favorable native vegetation within lakes (Madsen et al. 1991) and may limit light from reaching native aquatic plant species (Newroth 1985; Aiken et al. 1979). The aquatic plant frequently forms dense surface canopies on inland lakes such as Paradise Lake. Additionally, EWM can alter the macroinvertebrate populations associated with particular native plants of certain structural architecture (Newroth 1985). EWM beds have been associated with less macroinvertebrate biodiversity than native aquatic vegetation beds (Soszka 1975; Keast 1984; Cattaneo et al. 1998). The canopy created by EWM creates an unfavorable environment for aquatic biota through the creation of stagnant water conditions which lead to increased water temperatures and lower dissolved oxygen concentrations (Unmuth et al. 2000). Cheruvilil et al. (2001) studied the macroinvertebrate communities on EWM in six southern Michigan lakes and discovered that the number of macroinvertebrates on the most dominant plant species declines as EWM biomass increases. Since the introduction of EWM, many nuisance aquatic plant management techniques such as chemical herbicides, biological control, and in extreme cases, mechanical harvesting, have been implemented. EWM must be managed as it reduces native aquatic plant biodiversity, impairs navigation and recreation, and accumulates on shorelines which can be difficult to remove

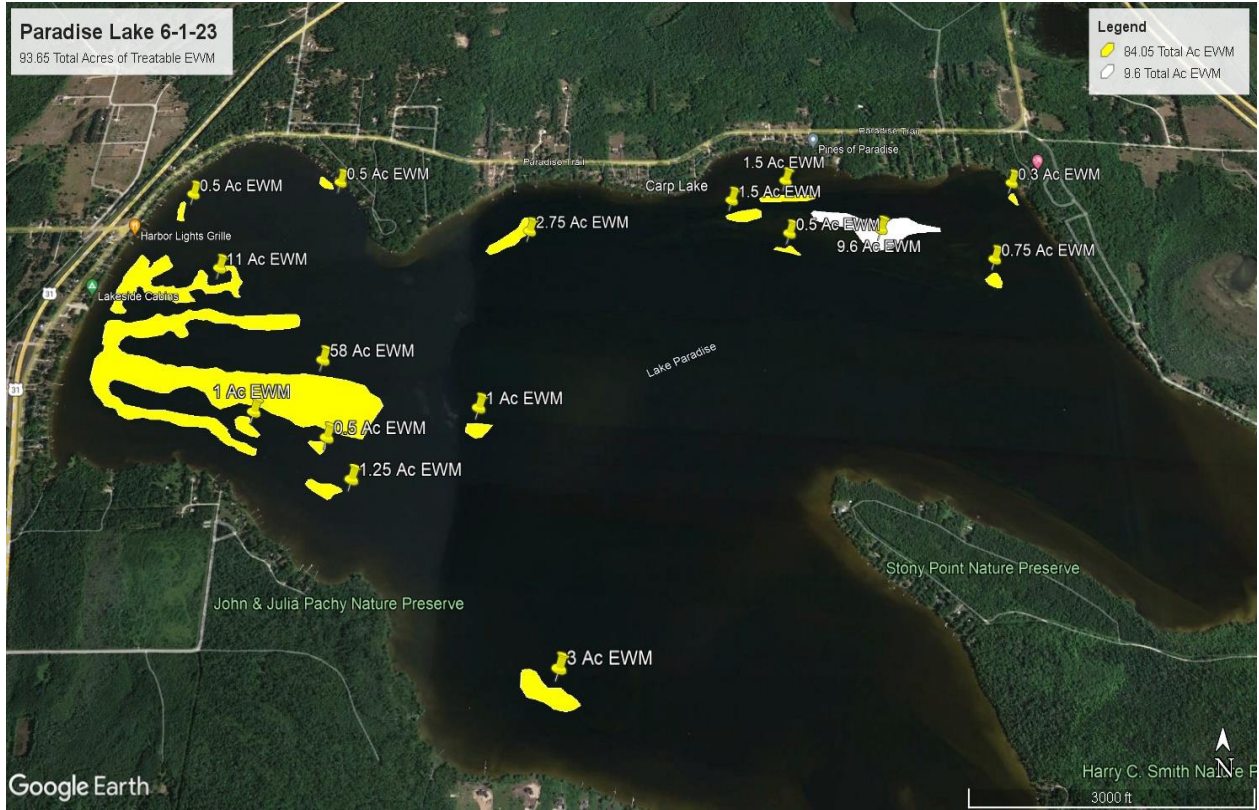
Figure 14. Eurasian Watermilfoil distribution (June 1, 2023)

Two whole-lake GPS surveys occurred on June 1, 2023 (pre-treatment) and on August 1, 2023 (post-treatment). Such surveys were conducted by aquatic scientists at RLS and consisted of 722 GPS sampling locations located throughout Paradise Lake and determined that approximately 98.6 acres of *M. spicatum* exists in the lake on the June 1 survey. This increase in growth relative to 2022 was due to a seedbank re-emergence that can occur at any time. The lake also contained a moderate amount of submersed native vegetation that includes pondweeds and other native milfoil species such a Whorled Watermilfoil (*M. verticillatum*).
